From spiral to helical stairs: Santa Cruz la Real and Santiago Apóstol approaches

P. Benítez, & M. Valiente

Universidad Politécnica, Madrid, Spain

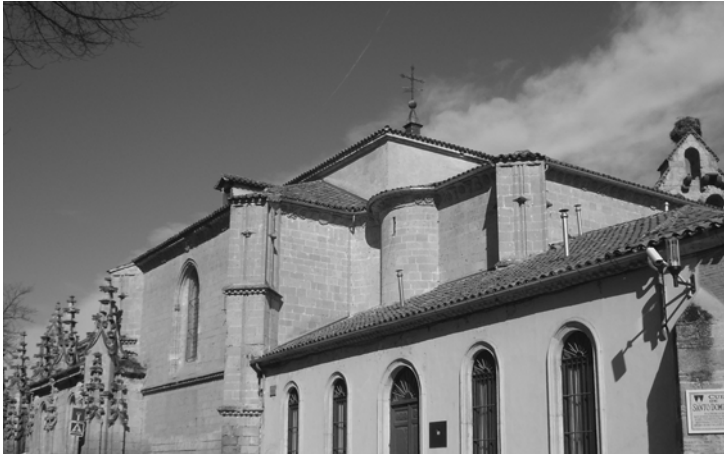
Figure 1 Church of the monastery of Santa Cruz la real. From left to right: staircase cylinder, apse and bell-gable. (Photograph by P. Benítez)

The stair is inscribed in a cylinder with 180 cm in diameter which in turn is attached to the wall apse and is visible from the outside even though it is half-buried (Figure1). Following a circular geometry solution, the stair has been shaped by a stone step turning around a central axis. In this case the newel is not vertical but helical and runs tangent to a small central hollow. Originally the stair had a total of sixty four steps. Nowadays it is in a very poor condition and only the first six steps at the bottom landing and eight steps at the end remain. The others have been replaced by timber steps which form a spiral stair with an evident provisional character. The last eight-step flight that remains is not usually treaded because the access to the attic is in the fifty eighth step, which is the last added timber one.

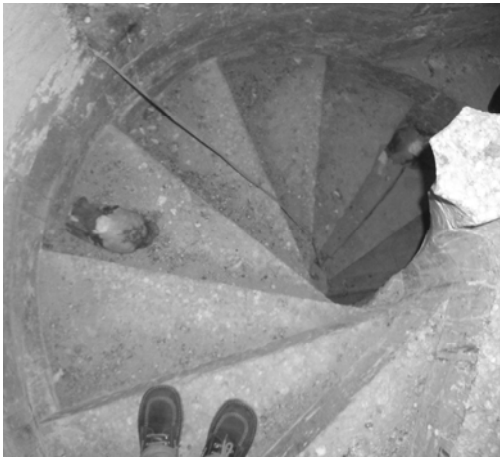
Figure 2 Last eight steps-flight of the staircase of Santa Cruz. (Photograph by P. Benítez)

A full turn requires fourteen steps to be completed. Each step rests on the one just below and is embedded in the exterior stair wall. They have a circular wedge shape that does not point to the geometrical center of the stair. Instead, it goes tangent to the hollow. The tread has a 45 cm long chord next to the wall and it narrows until it turns into an apex in the inner part. The unit riser is 20cm high (Figure 2). As we will see, this feature makes this Gothic helical staircase a significant example as this step module was not commonly used.

The intrados is a smooth helical surface that determines 280 cm of headroom all along the stairway. A handrail is carved in the exterior wall 83 cm above the tread. It continues until the church attic, although it is interrupted once to form a door frame molding, which seems to give access to a church inside gallery. After analyzing the interior masonry walls of the crossing and

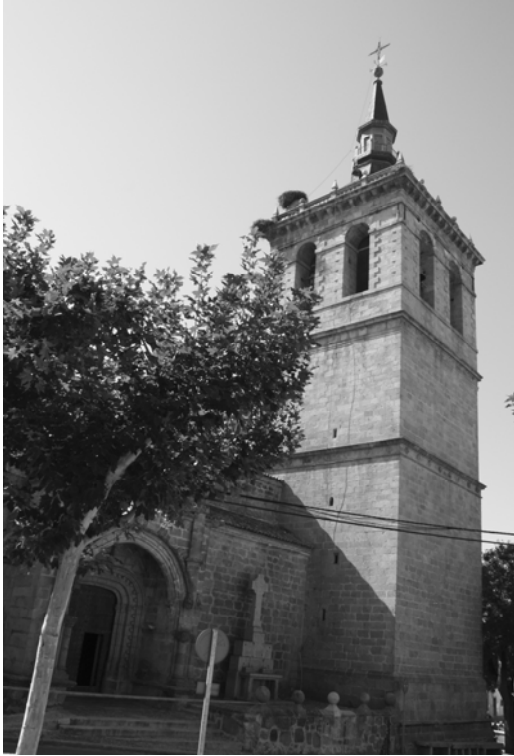
Figure 3 The tower of Tolosa. Santiago Apóstol church. (Photograph by P. Benítez)

The parish church of Santiago Apóstol is located in Villa del Prado main square. It is a village at the south east area of Comunidad de Madrid and near Toledo. Its construction took place from the late fifteenth up to the mid- sixteenth century, therefore the transition from the late Gothic to the Renaissance can be appreciated. The building has two towers: (i) the older one of Gothic style that is finished with a bell-gable; and (ii) the Tolosa tower with an obvious renaissance influence. The last one contains the stair that is aim of this study (Figure3).

The tower is detached to the north east side of the church. It has 10mx10m square plan and is 30m high that is divided into 3 sections. During its construction, many masters took part in it due to the frequent economic problems. According to the Account Books of the church construction, the tower was designed by Juan Campero around 1544. He was an important master who worked in Segovia in the construction of many relevant buildings like the monastery of El Parral and the moving the cloister of the Saint Mary old Cathedral, designed by master Guas, to its actual location. Ochoa de Muniategui helped him with the building works of the first section of the tower (Marías, 1986). Another important figure was Pedro de Tolosa, master mason of El Escorial. He resumed the works and raised the second section of the tower following the design of Muniategui, according to the duties settlement that is kept in the parish archive. Another important figure was Pedro de Tolosa, master mason of El Escorial, who restarted the works and raised the second tower section following the design of Muniategui as it is written in the duties settlement that is kept in the parish archive. The tower was finished by the master Lorenzo in the late sixteenth century, following the last design of Hernán González de Lara. The Account Books just indicates the name of the master who finished the tower, Lorenzo, not including any additional data about him. Moreover, in the literature, there are no further references about this person or any of his works. Finally in the 1990s the lack of maintenance motivated its restoration, whose author was the architect Riaño Lozano.

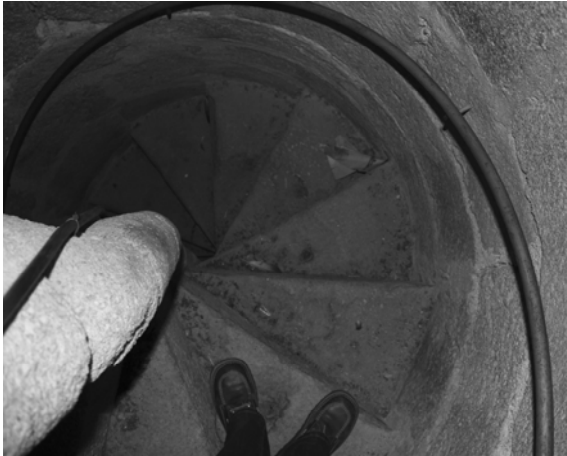
Figure 4 Staircase of Santiago Apóstol Church. (Photograph by P. Benítez)

The third flight is the more interesting one. It is located in the southeast corner of the tower and gives access to the bells group room. It is a stair with a simple circular plan that at the first glance looks like a traditional spiral stair. It is inscribed in a small cylinder of 130cm in diameter that is only visible from the same room as the first flight. It turns clockwise and has twelve steps in every turn. The trasdos surface of the first three steps is helical, but from there on remains stepped. The feature we want to point out is that the traditional central newel that begins at the seventh step is not vertical. It slightly deviates from the central axis until the twenty-seventh step where the newel goes back to the central axis again. Each step is 68 cm wide. Its tread has a 35cm long chord next to the wall which narrows until it turns into an apex in the inner part. Its riser height is 20cm. From the bells group room on, a last flight give access to the flat roof of the tower. It is solved by using a traditional spiral staircase that is inscribed in a cylinder with the same dimension as the previous one (Figure 4)
